The Pothole Patrol

6.S062 Spring 2018
Lecture 8
3/6/2018

Balakrishnan & Adib

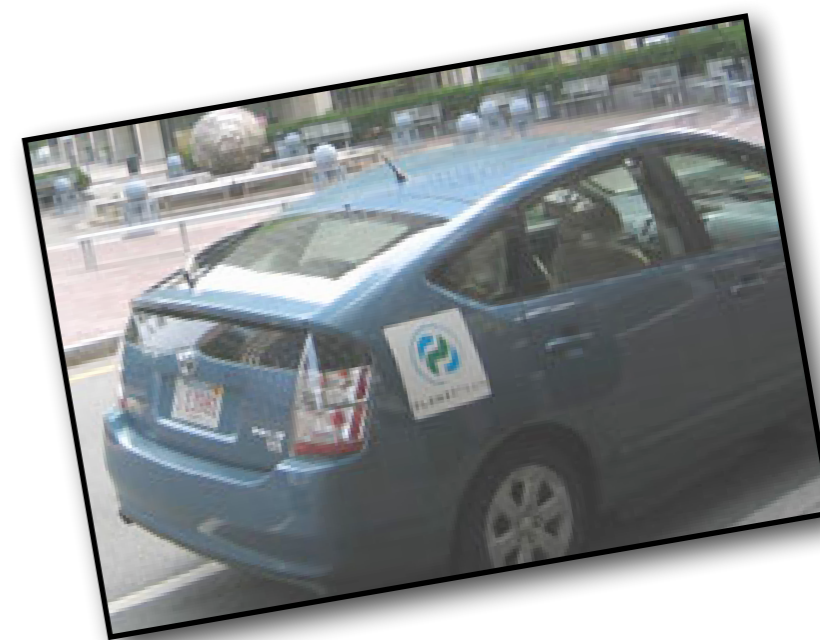
experimental platform

- 7 Boston/Cambridge taxis
- small computer in glove box
- 380 Hz 3-axis accelerometer
- 802.11a/b/g wireless interface
- GPS receiver on roof
- $\langle \text{time, location, heading, speed, } a_x, a_y, a_z \rangle$

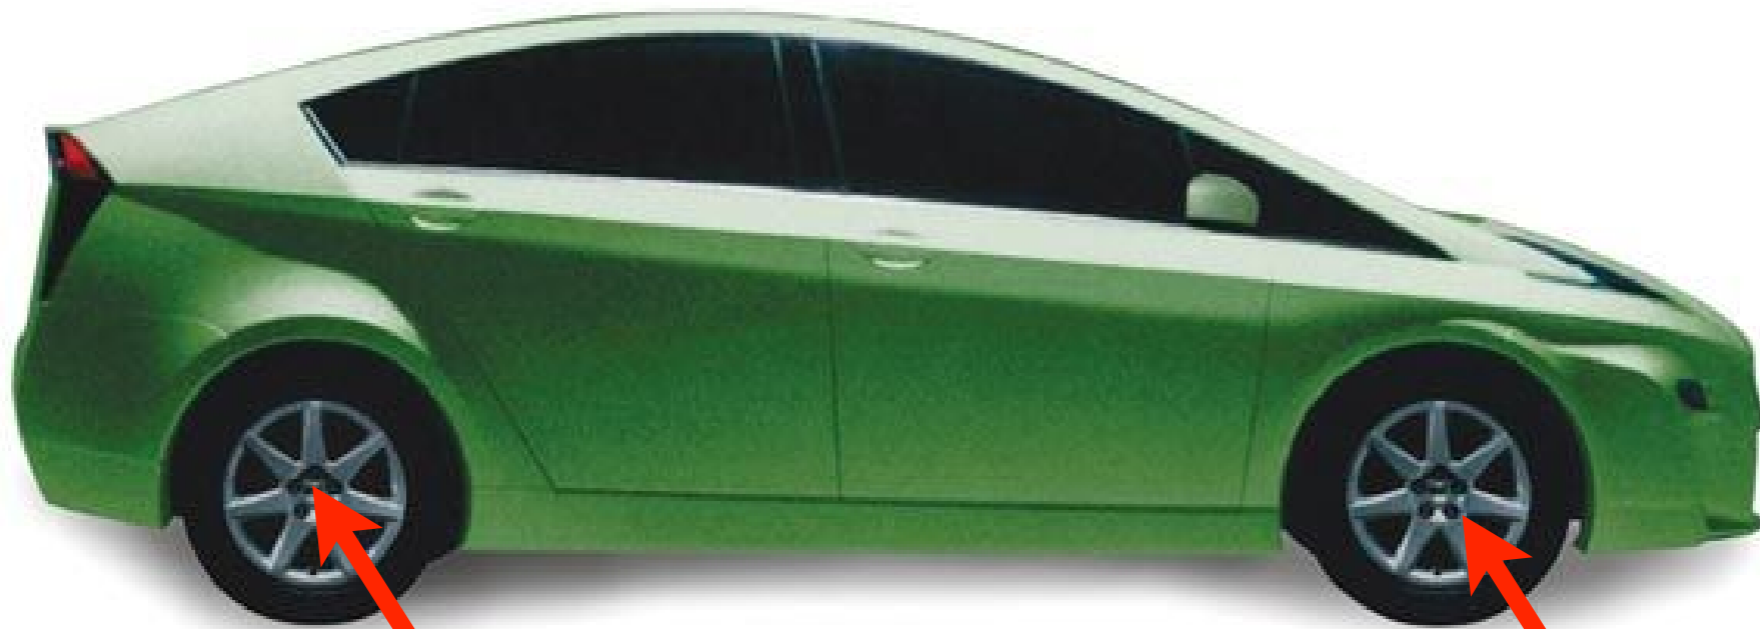
sensor placement

try to stay
inside vehicle

- highly accurate
- difficult mounting
- extreme exposure

- very clean signal
- 'gold standard'
- difficult to mount

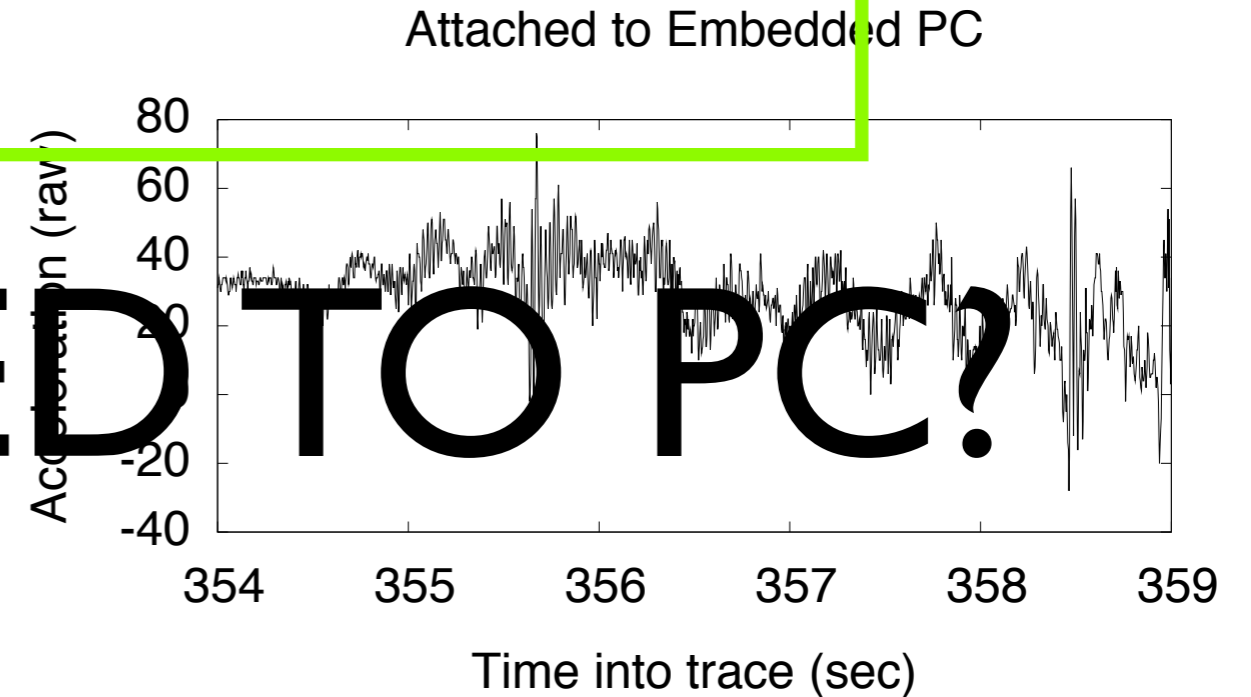
- very poor signal
- no mounting necessary

ATTACHED TO PC?

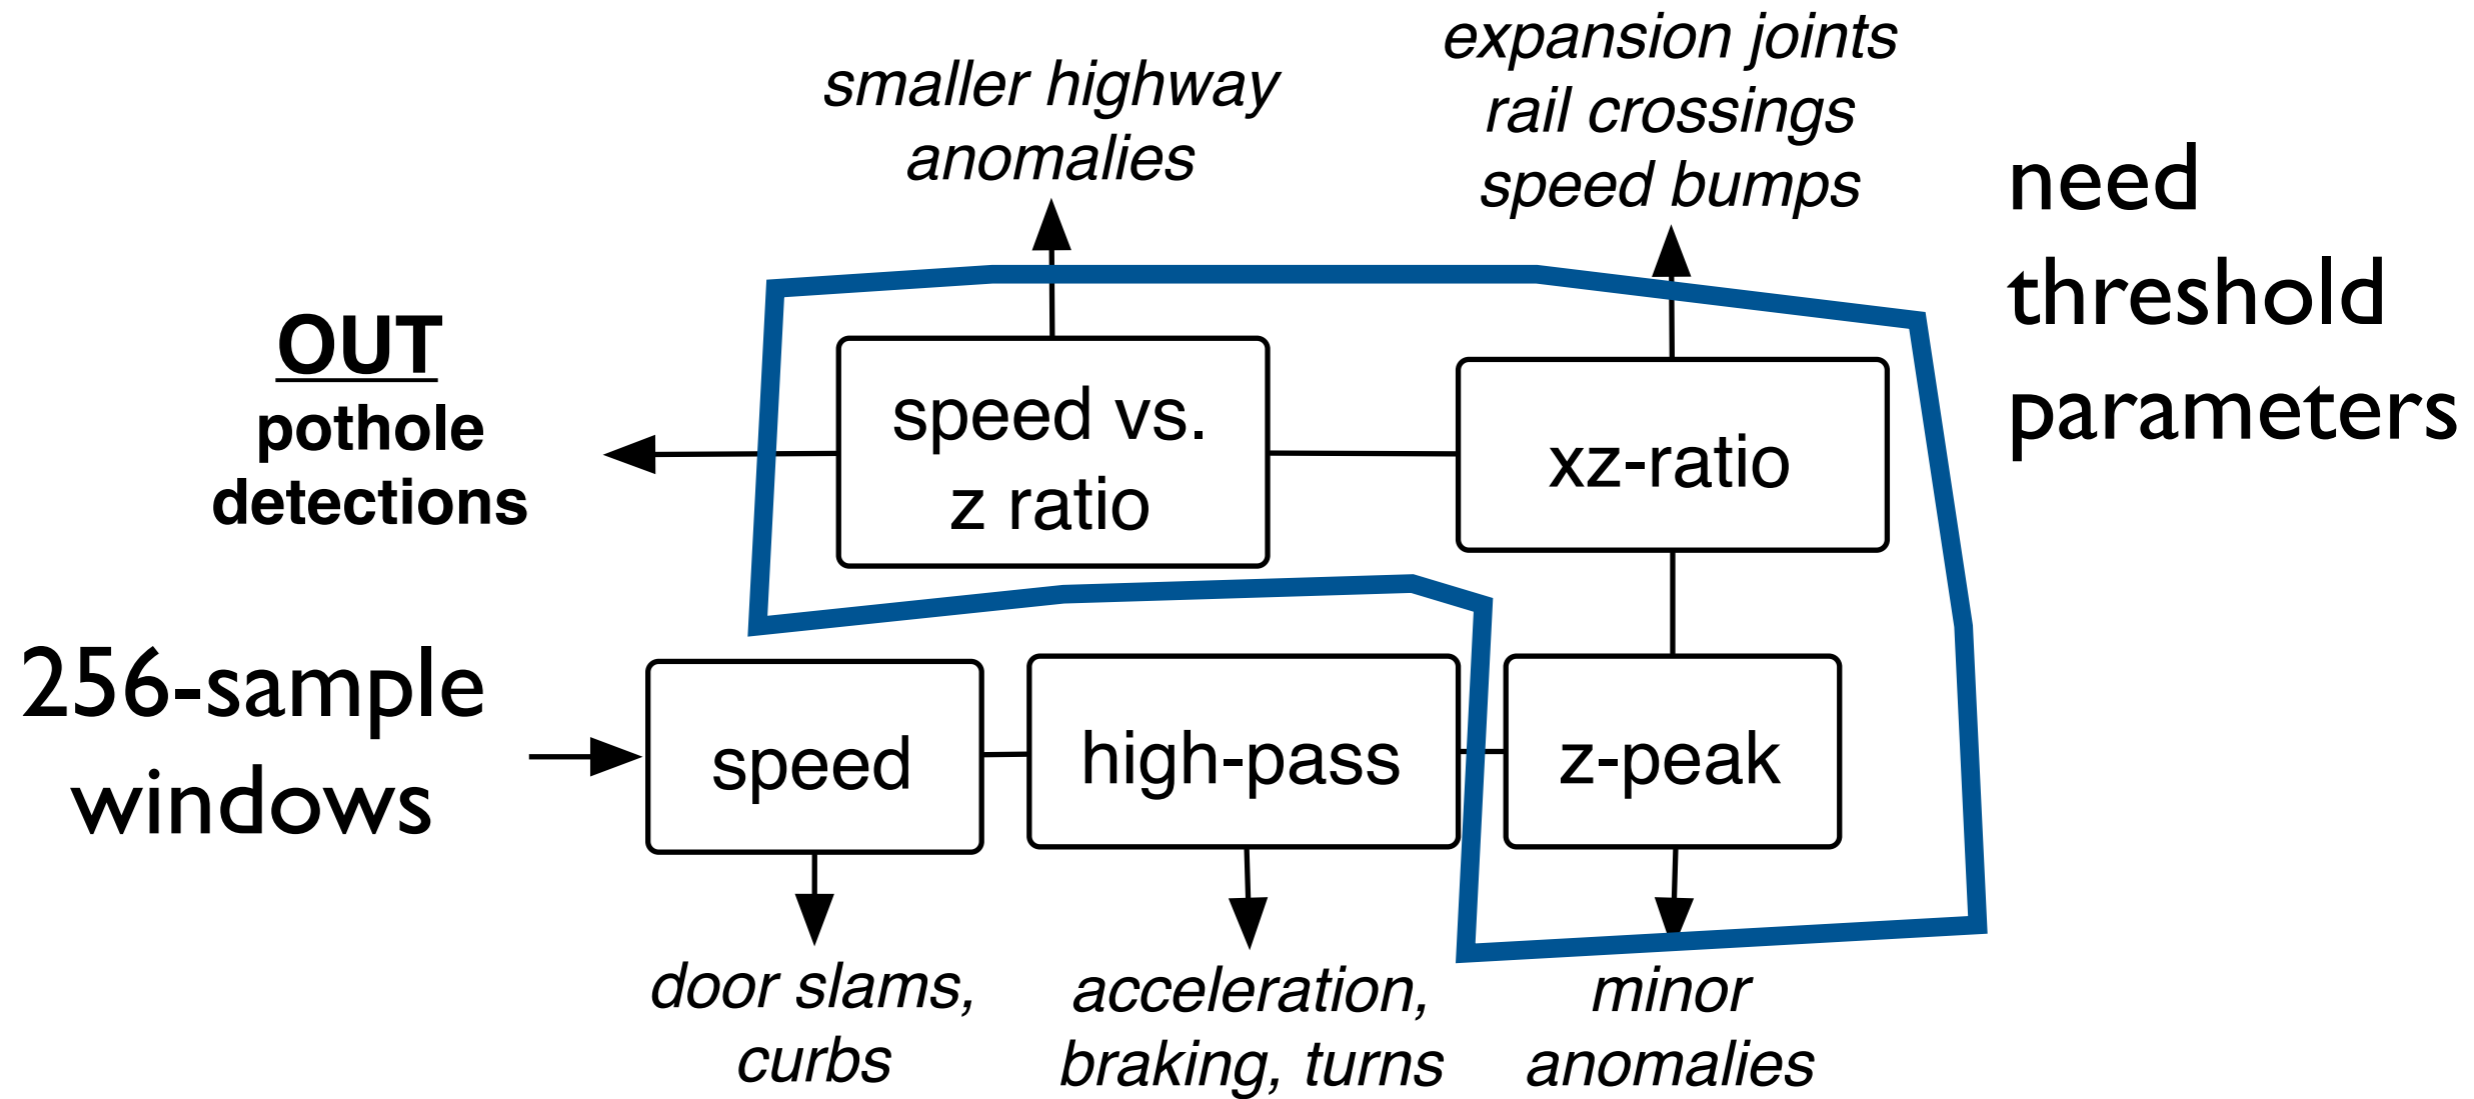
P² detector

Events usually of much shorter duration than 256 samples

- optimize over 3 threshold parameters
 - z-peak
 - xy-ratio
 - speed vs. z-ratio
